Transportation

Assemblymember Linda Rosenthal November 2007

Upper West Side Senior Pedestrian Safety Plan November 2007

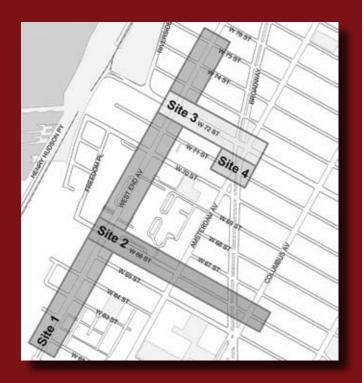
Study Area

Site 1: West End Avenue - West 61st Street to West 75th Street

Site 2: West 66th Street – West End Avenue to Columbus Avenue

Site 3: West 72nd Street – West End Avenue to Amsterdam Avenue

Site 4: Broadway and Amsterdam Avenue at West 71st Street

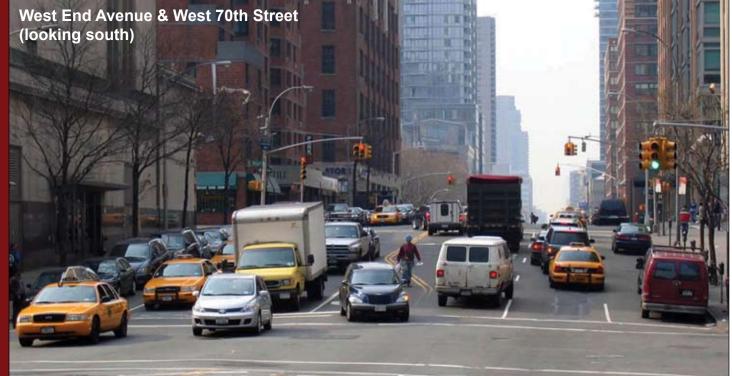
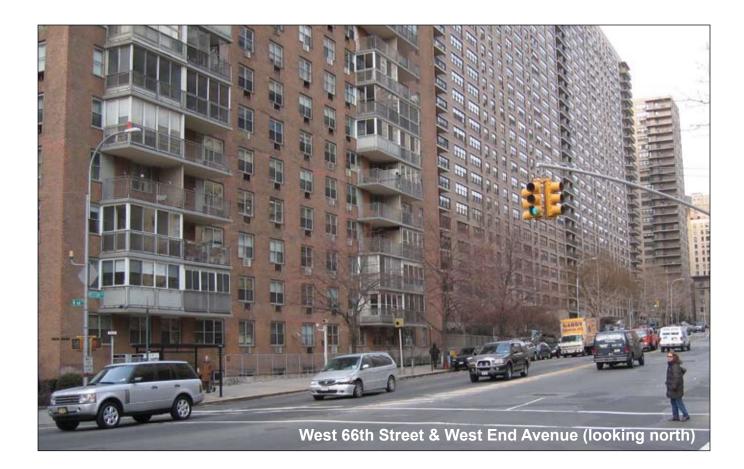
Most residents that live on the west side of West End Avenue cross the street daily to access the neighborhood. Due to the width of the street, and the short length of the pedestrian walk signal, senior citizens are stuck having to engage in an uncomfortable situation on a regular basis.

Motorists on West End Avenue and the cross streets included in Site 1 routinely fail to yield to pedestrians in the crosswalk, in particular at West 72nd street, West 66th Street and West 61st street. This behavior is consistent with past Safe Routes for Seniors studies that have found that 95% of motorists fail to yield to pedestrians in New York City.

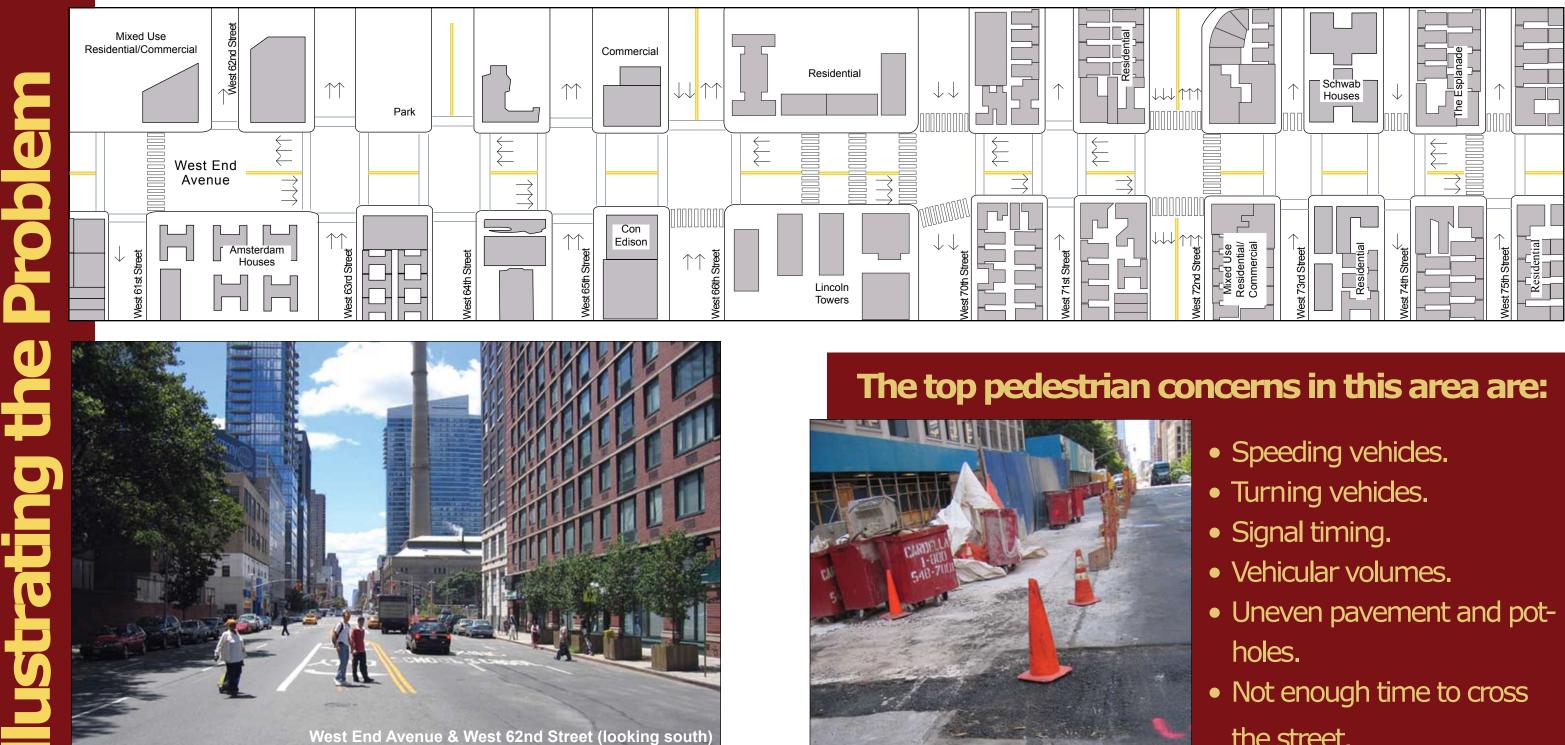
Existing Conditions (cont.) West End Avenue

The existing street geometry of three northbound and three southbound lanes holds true for the majority of West End Avenue. At West 70th street, West End Avenue is reduced to two northbound lanes due to construction and maintains this configuration for several blocks. West End Avenue traditionally operates at an average level of capacity, with primary delays taking place at West 72nd street where the majority of motorists are turning from West End Avenue to West 72nd Street in both directions.

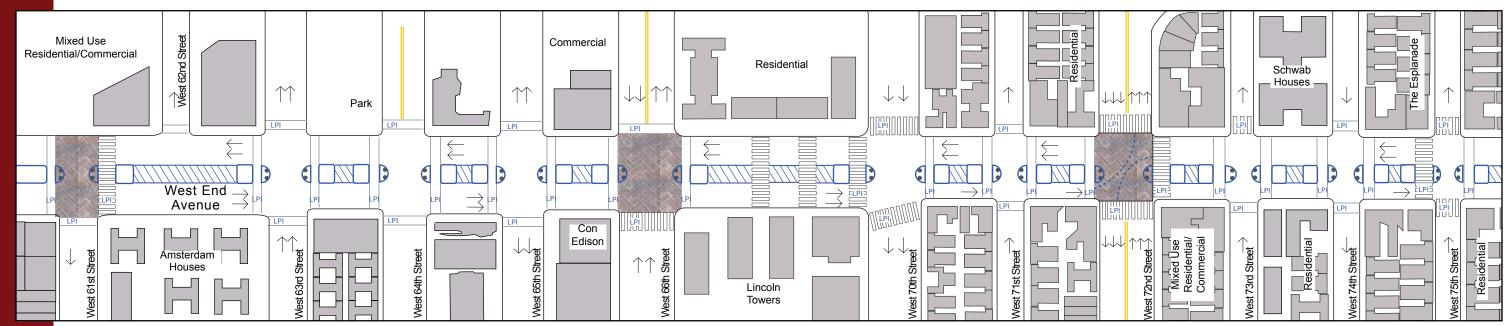
Proposed Changes West End Avenue

The following recommendations include:

- Median and median tips with bollards.
- Leading pedestrian intervals at each intersection.
- left turn.
- motorists.
- New bus shelters and benches throughout.
- Street and West 72nd Street.

• Replace signals at West 72nd street for the designated

• Paint channelizing stripes at West 72nd street to direct

• "Street Print" pavement treatments at the intersections of West End Avenue and West 61st Street, West 66th

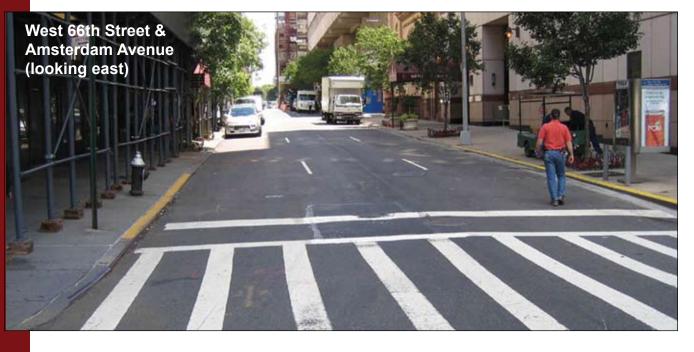
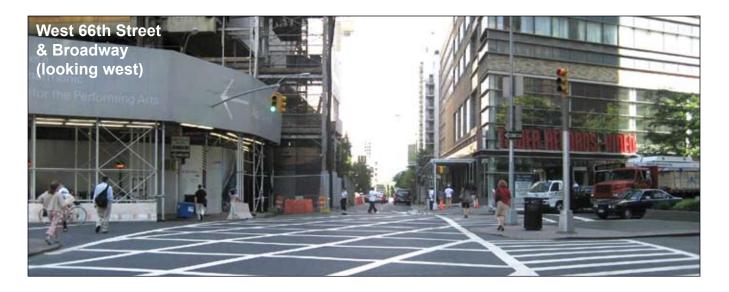
Motorists traveling westbound on West 66th Street turn quickly to southbound West End Avenue, cutting off pedestrians at high rates of speed. The M66 bus typically drives over the double yellow line in order to make this turn without slowing down.

At Amsterdam Avenue and West 66th Street, motorists speed through the intersection as both streets are excessively wide with long view corridors, another design feature encouraging people to speed. This is particularly dangerous at this intersection as there are many teenagers crossing Amsterdam Avenue from east to west to attend school. The fire station on the southeast corner of the intersection further complicates standard traffic patterns as fire trucks frequently drive quickly diagonally across the intersection making the turn onto West 66th street with a high rate of speed.

West 66th Street crosses Broadway at a slight diagonal and rise, creating a visually difficult crossing for westbound motorists. The intersection is striped with a "Don't Block the Box" grid pattern to help keep the intersection clear of motorists and pedestrians during the different signal phases. This intersection typically maintains three travel lanes and one parking lane in each of the North/South directions, though this configuration has been modified on both sides of Broadway due to construction on the northeast and southwest corners, though this configuration has been modified on both sides of Broadway due to construction on the northeast and southwest corners.

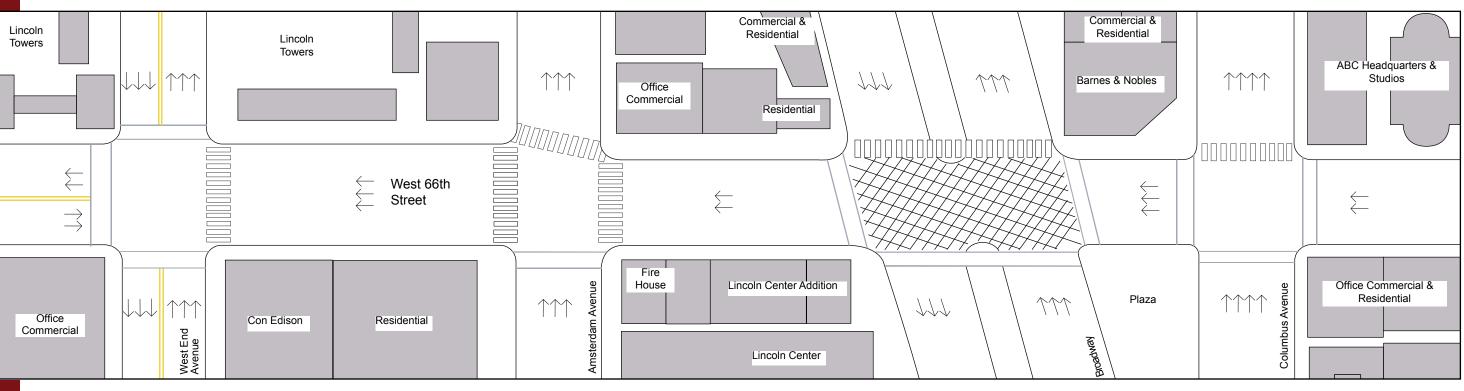
Existing Conditions (cont.) West 66th Street

West 66th Street is an excessively wide, one-way street that carries anywhere from two to three lanes of traffic depending on parking regulations. Going from east to west across Amsterdam Avenue, West 66th Street increases in width by 10 feet. This, coupled with the long blocks between each avenue leads to high vehicular speeds. Unfortunately the long blocks also lead to jaywalking, especially at Lincoln Towers, where residents don't want to walk hundreds of feet out of their way to cross at a signalized intersection. A mid-block crossing could be installed on West 66th Street between Amsterdam Avenue and West End Avenue to make this situation safer.

The top pedestrian concerns in this area are:

- Speeding due to wide streets and wide avenues as well as cut through traffic to West End Avenue.
- Turning vehicles fail to yield to pedestrians.
- The blocks in this area are long; everyone jaywalks. There are no safe mid-block crossings.
- There is not enough time to cross the street.
- Fire trucks pull in and out of the station without looking.
- Fire Department employees park on the sidewalks.

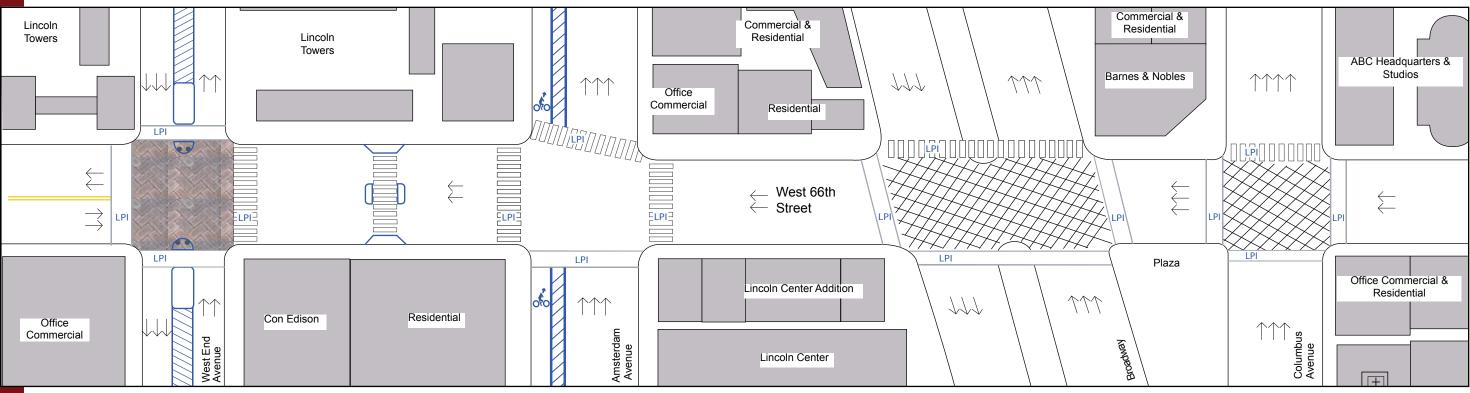
Proposed Changes West 66th Street

The following recommendations include:

- enue.
- West End Avenues with curb extensions.
- West End Avenue.

• Leading pedestrian intervals at all legs of every crossing. • Median pedestrian refuge at West 66th Street and West End Av-

Midblock crossings on West 66th Street between Amsterdam and

• Install protected bike lane. The bike lane would begin at West 57th Street and terminate at 69th Street, one block before the intersection where Amsterdam Avenue crosses diagonally over Broadway. • "Street Print" treatment at the intersection of West 66th Street at

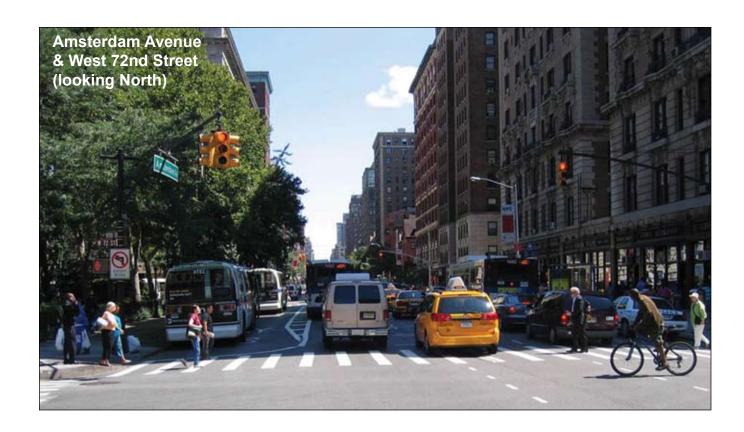
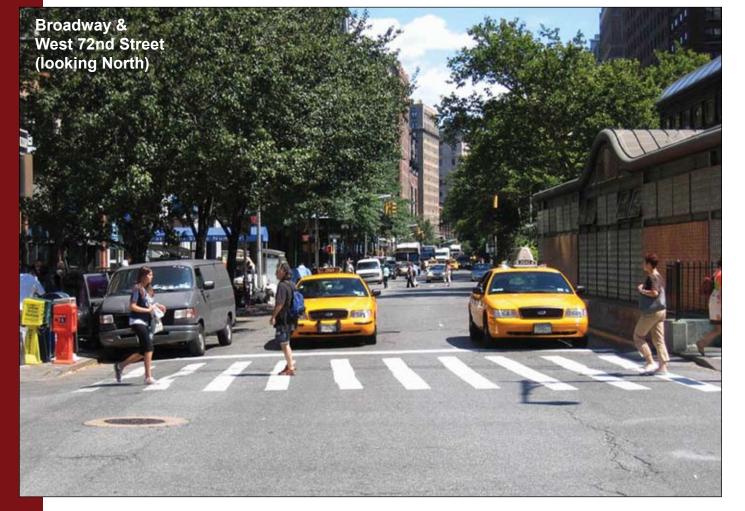
West 72nd street is 100 feet wide from building line to building line, with three travel lanes in the west and east directions with parking on both sides of the street. West 72nd is a major through street on the Upper West Side.

West 72nd street at Broadway and Amsterdam Avenue is a busy area where pedestrians routinely battle the through and turning north and south bound buses that travel on these wide streets. Broadway and Amsterdam Avenue at West 72nd street create a unique intersection due to the 72nd street subway situated between these two streets. Pedestrians and motorists have a difficult time understanding how to move safely through this intersection together, making for a lot of near misses and the unfortunate crashes.

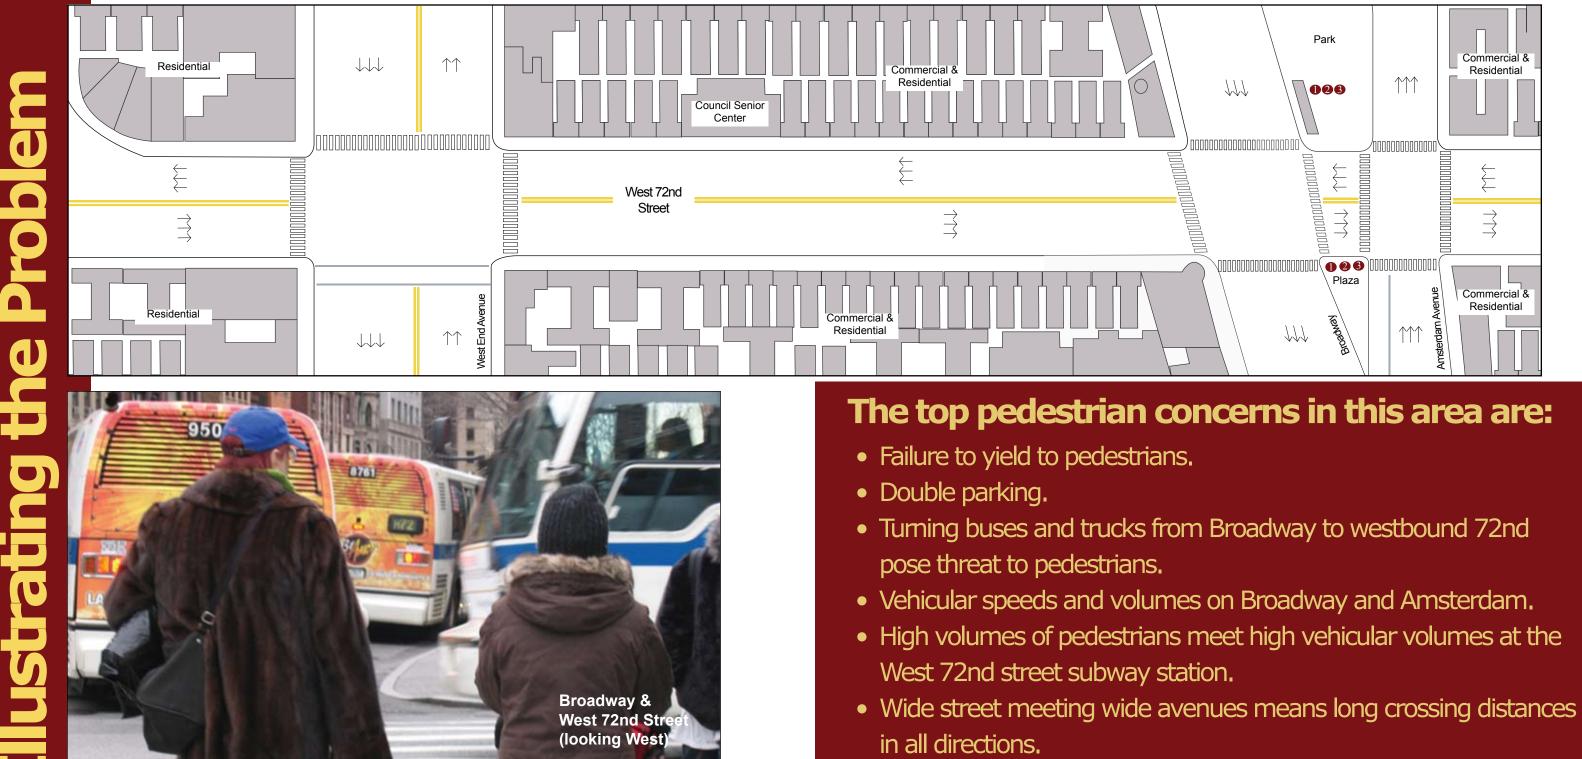
Existing Conditions West 72nd Street

• Elderly don't feel like they have enough time to cross the street. Sidewalks and curbs are cluttered.

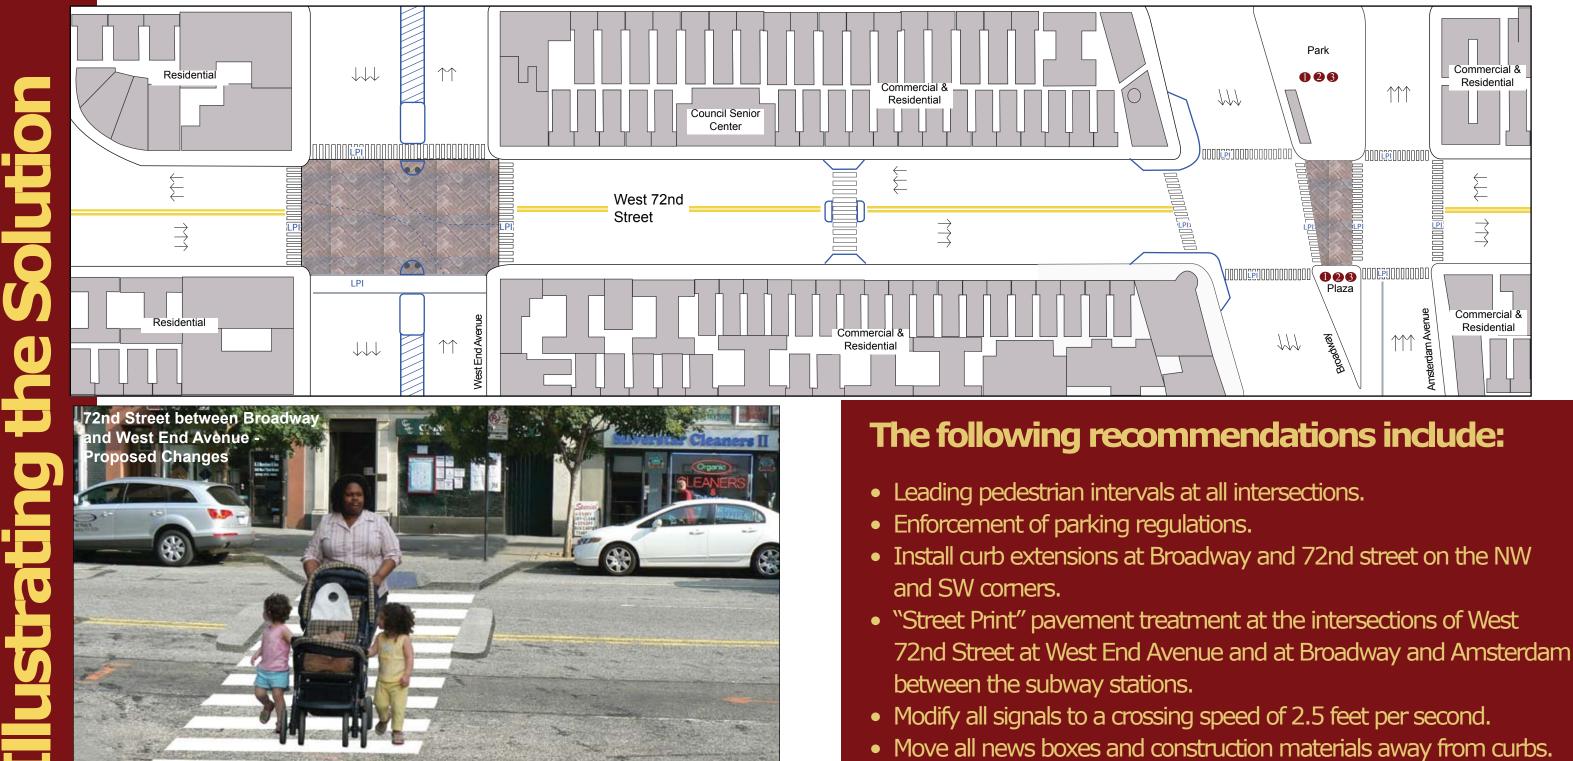
Proposed Changes West 72nd Street

• Create mid-block crossing on West 72nd Street between Broadway and West End Avenue.

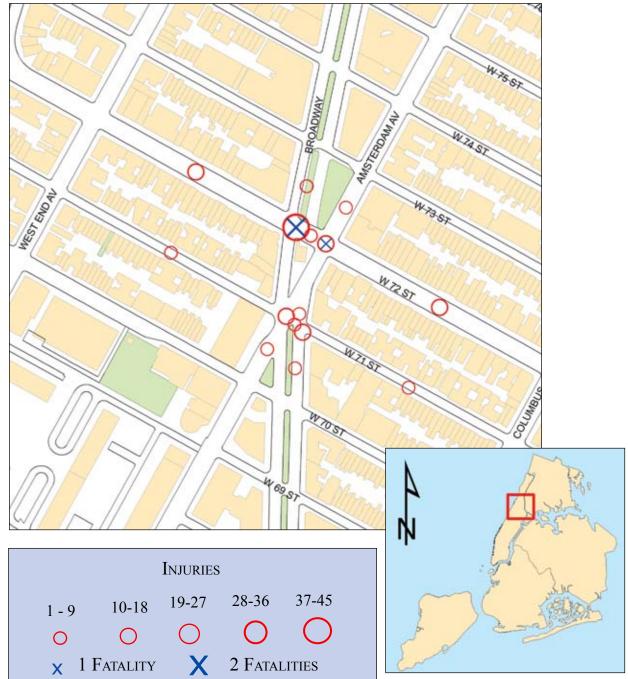
Site 4 Pedestrian Crash Statistics (1995 - 2005)

Injuries	5
1 - 9	10-18	19-27	28-36
0	0	0	0
х 1 I	FATALITY	X	2 Fata

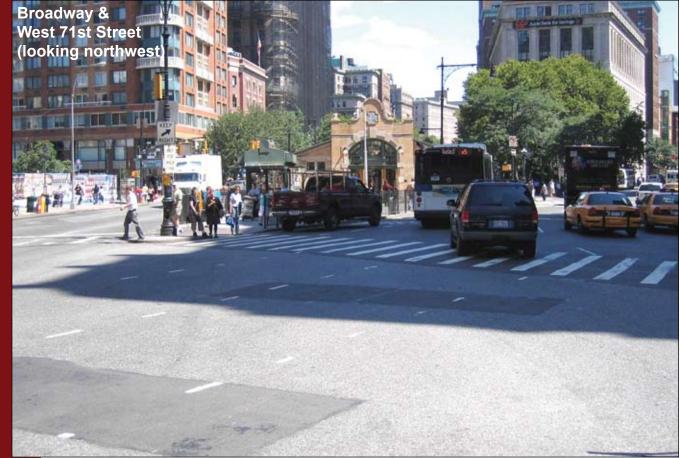
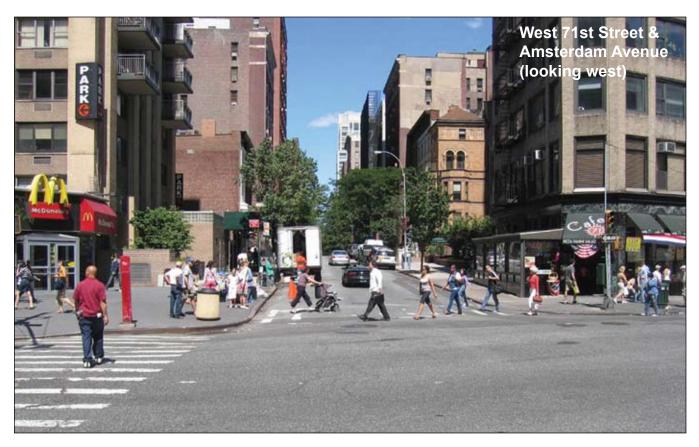
Further complicating this intersection are the raised pavement areas designed to separate directions of traffic through the bow tie. A triangular area separating north bound traffic on Amsterdam Avenue from southbound traffic on Broadway serves as an additional pedestrian refuge.

All users at this intersection tend to behave erratically as they attempt to get out of this confusing area as quickly as possible. Southbound motorists on Broadway drive with excessive speed when capacity allows for it, which is particularly dangerous at this location due to the high pedestrian volumes. Northbound motorists on Amsterdam Avenue

have a difficult time understanding where they are supposed to go as the lane changes reguires drivers to cross diagonally through a long intersection.

The best way to make this area safer for pedestrians and cyclists is by adding additional space to the current medians on either side of the Broadway, thus reducing the width of the asphalt used by motor vehicles. This would slow down motorists by narrowing their passage through this intersection and allow pedestrians a greater area to wait between crossings.

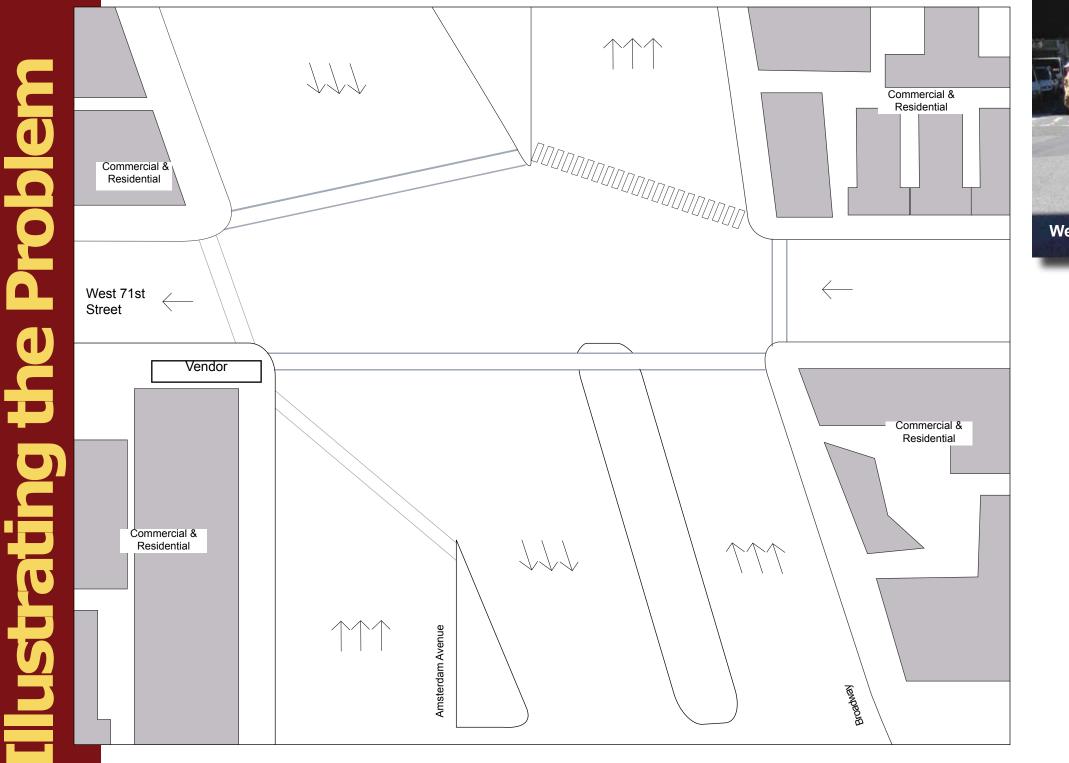
Existing Conditions Broadway & Amsterdam Avenue

The intersection of West 71st street at Broadway and Amsterdam Avenue is a complicated crossing often requiring pedestrians to use two pedestrian light phases to complete an east-west movement. On the south side of the intersection the Broadway mall provides sufficient refuge for pedestrians, whereas on the north side pedestrians must wait on the end of the raised triangle that makes up the 72nd street subway station.

The top pedestrian concerns in this area are:

• Long east-west crossings.

• High pedestrian volumes at subway and local schools, especially at the McDonalds on the south west corner of the intersection. • Diagonal crosswalk at Amsterdam is too long

and vehicles tend to stop in the crosswalk. • Confusing "bow tie" geometry is difficult for all

• Vehicles tend to speed through the intersec-

• Vehicles turning from Broadway to westbound 71st street do not yield to pedestrians. • Newspaper boxes and vendors block the pedestrian ramp on the SW comer of the inter-

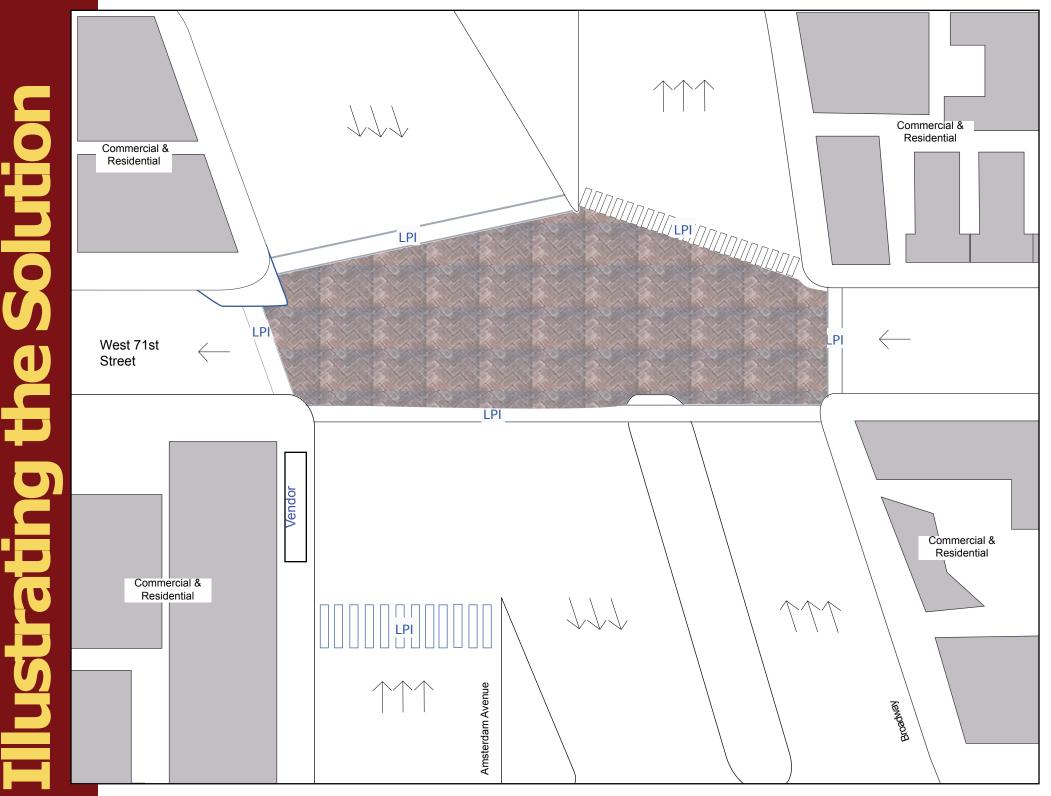
Proposed Changes Broadway & Amsterdam Avenue

- pendicular.
- Consider curb extensions on West 71st street on the NW corner.
- Add "Street Print" treatment to the intersection of West 71st Street at Broadway and Amsterdam to slow down motorists and improve the existing quality of the pavement at these intersections.
- Move vendors south of the intersection on Amsterdam, away from West 71st street.

The following recommendations include:

- Leading pedestrian intervals at every crossing and give adequate time to cross the street. • Channelize vehicles as much as possible
 - through the intersection.
- Make the diagonal crossing of Amsterdam per-
