## 2018 WINTER AND SPRING STORMS INVESTIGATION

Case 19-M-0285 - In the Matter of Utility Preparation  
and Response to Power Outages During the March  
2018 Winter and Spring Storms

New York State Department of Public Service

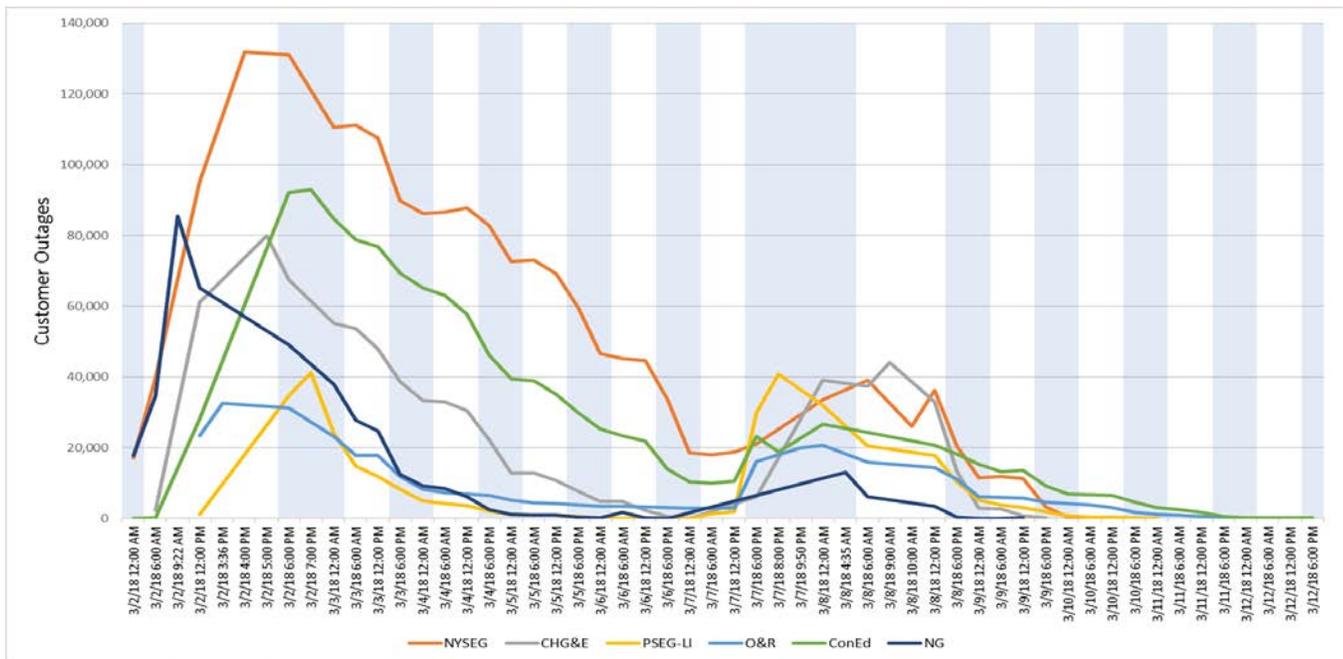
Figure 1: The Restoration curves for Winter Storm Riley and Quinn (All utilities)

Figure 1 shows the restoration curves for Winter Storms Riley and Quinn for all six major utilities greatly affected by the storms. Approximately 90 percent of customers in the PSEG LI and National Grid service territories were restored on March 4, 2018. PSEG LI restored all customers around midnight on March 5, 2018 and National Grid restored all customers on March 6, 2018. Central Hudson and Orange & Rockland restored 90 percent of its customers on March 5, 2018. Central Hudson had fully restored all customers impacted by Winter Storm Riley on March 6, 2018. By March 7, 2018, more than 90 percent of customers in the Con Edison and NYSEG service territories were restored. However, that same day, a second powerful weather system, Winter Storm Quinn, proceeded to hit many of the same areas in the lower Hudson Valley, with predictions ranging from 12 to 18 inches of additional snow, as shown in Figure 2. Winter Storm Quinn caused more outages and hindered on-going restoration efforts by Con Edison, NYSEG, and Orange & Rockland.

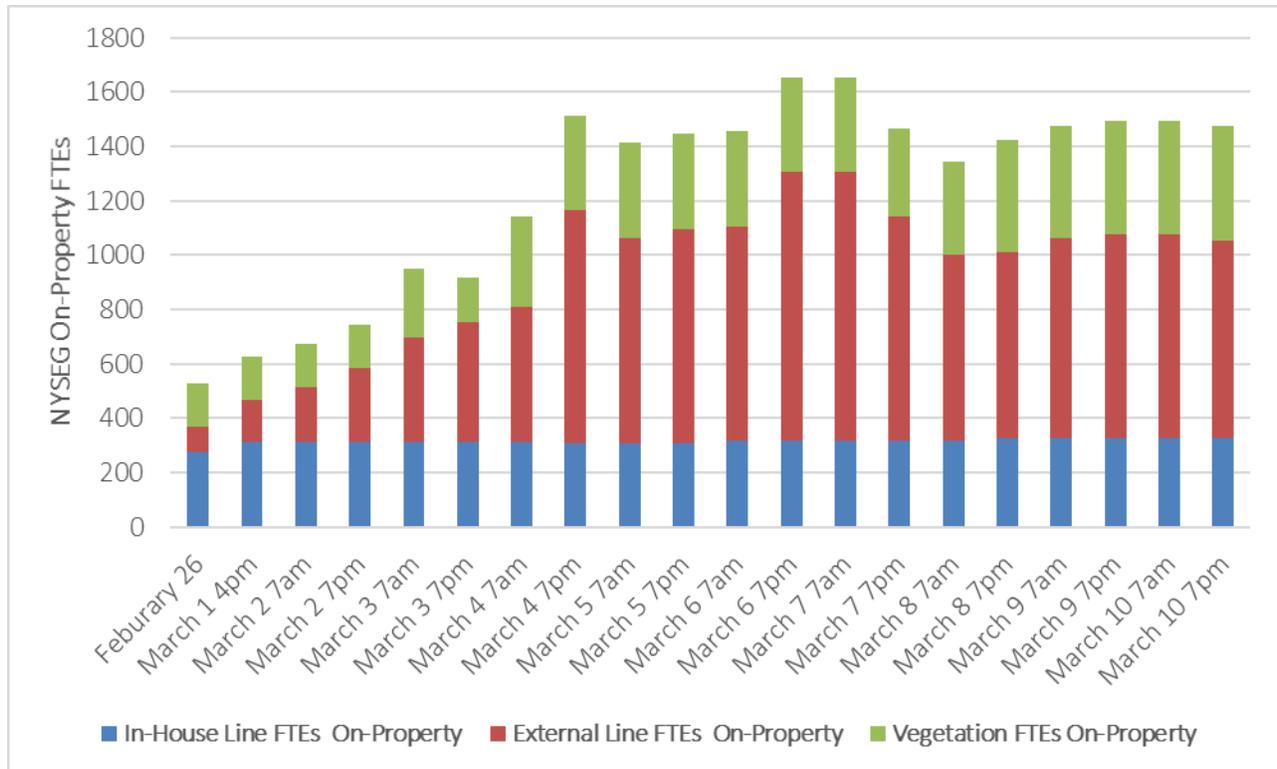
Figure 6: NYSEG’s On-Property FTEs<sup>30</sup>

On February 28, 2018, NYSEG initiated contact with the administrator of the NYP/PUMA, however, resources were not available during the initial NYP/PUMA call.<sup>31</sup> The first NAMAG call took place on February 28, 2018 at 9:00 PM and all member utilities were holding resources except Hydro Quebec, which offered 120 FTEs. In addition, on February 28, 2018, NYSEG/RGE requested 74 contractor FTEs outside of the NAMAG process. All 74 FTEs were received by March 1, 2018.<sup>32</sup> Prior to the second NAMAG call, scheduled for March 1, 2018, NYSEG/RGE’s contract meteorologist’s forecast increased the storm’s potential impact; indicating the storm would result in substantial damage in parts of NYSEG’s

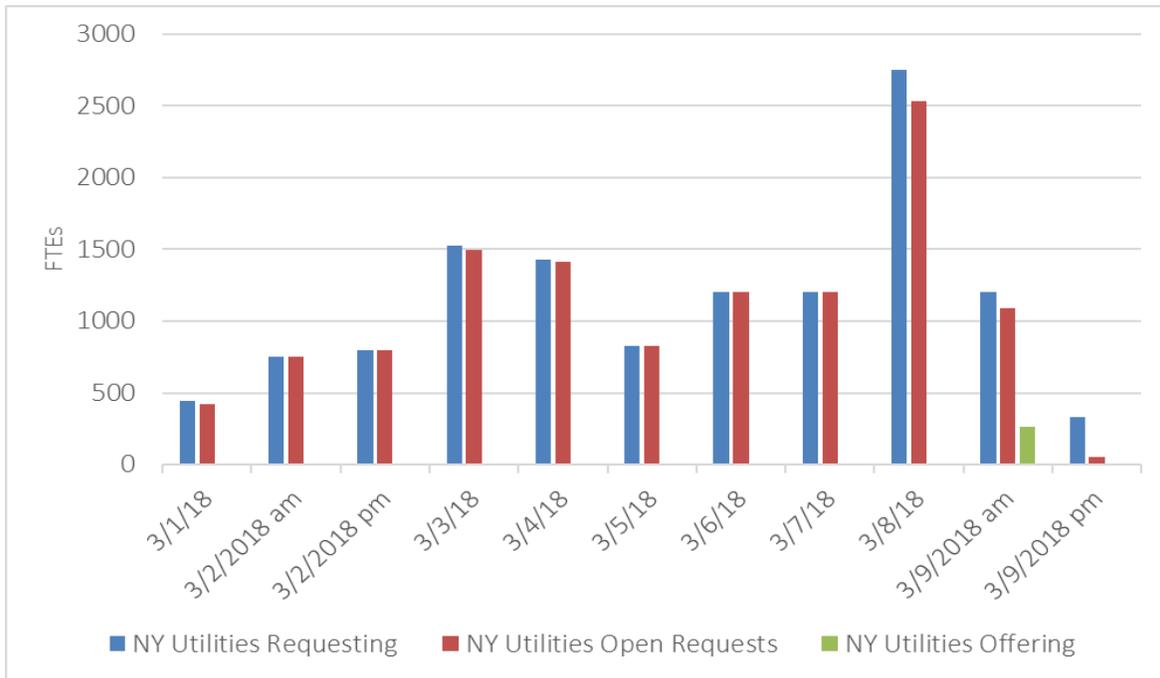
Figure 7: Summary of FTEs Discussed on NAMAG Calls<sup>36, 37</sup>

As can be seen in Figure 7, despite efforts to obtain additional line resources once the forecasted severity of Winter Storm Riley increased, New York utilities secured a very small percentage of the requested resources through NAMAG. NAMAG was inoperative early on, because member utilities were unwilling to offer their FTEs until the storm’s impact on their electric system was known and/or restored. While mutual assistance is effective in addressing resource needs caused by smaller storms, the process did not adequately address the outages caused by Winter Storm Riley and Winter Storm Quinn. Unfortunately, the majority of allocations, 602 line FTEs or just over 91 percent of the 659 line FTEs sent

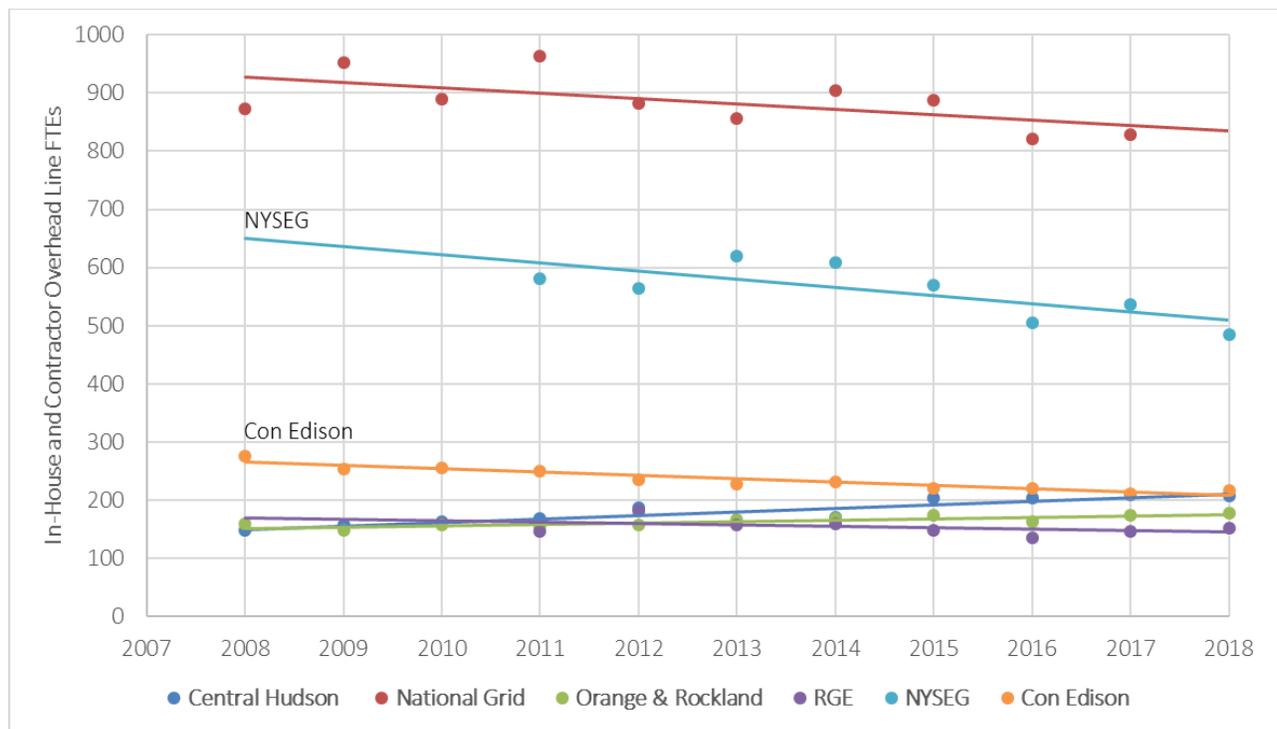
Figure 8: Total Number of Overhead Line FTEs by Utility Between 2008 and 2018<sup>47</sup>

Given the considerable additional resources required to restore customers following Winter Storms Riley and Quinn and the dependence on outside resources, Staff found it appropriate to review the existing staffing levels within each utility. Figure 8 shows the total number of line FTEs by utility between 2008 and 2018. This figure includes both the number of internal overhead line FTEs and an

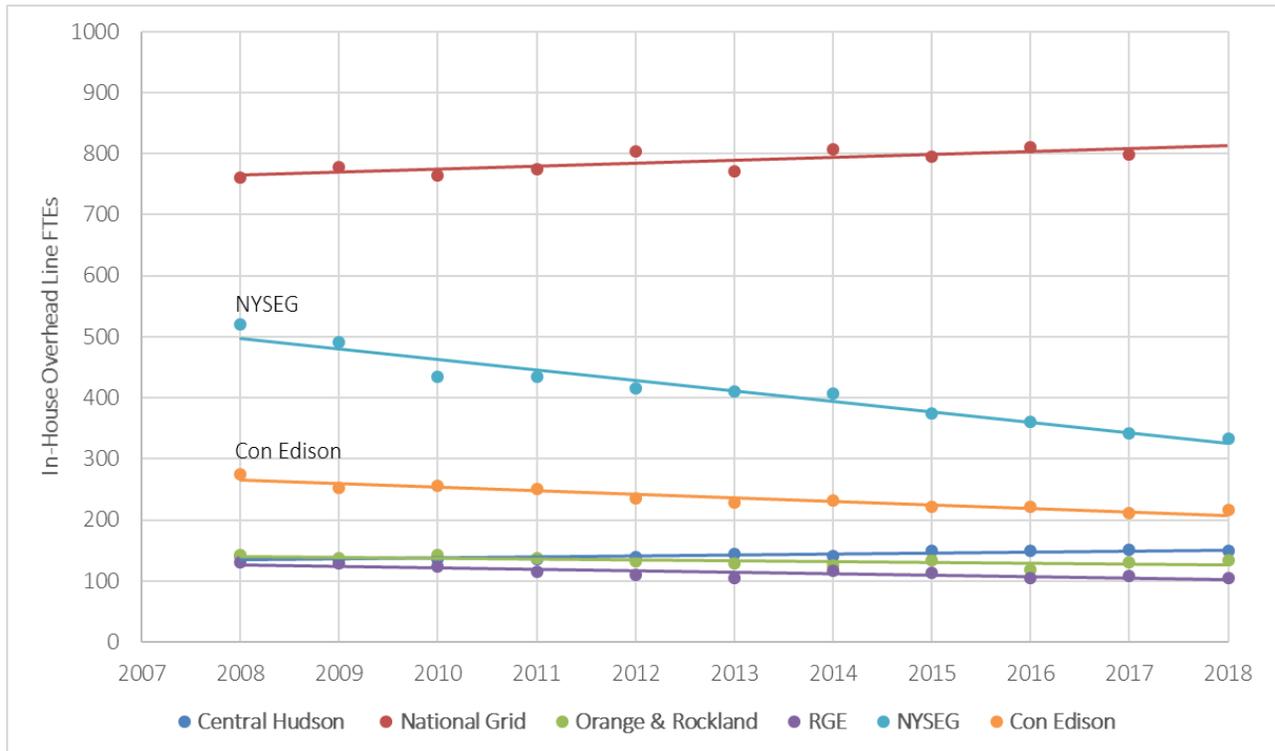
**Figure 9: Number of Internal Overhead Line FTEs**

average number of contractors used daily to perform construction or maintenance activities. Figure 9 represents the level of internal overhead line FTEs only. The blue and orange lines, in Figure 9, show a clear decline in the number of internal overhead line FTEs for both NYSEG and Con Edison, respectively. Conversely, Central Hudson (dark blue line) and National Grid show increases in internal overhead line FTEs over the same period. While NYSEG has offset the staffing reductions with contractors, that effort has placed the utility at a significant disadvantage regarding storm response, particularly in its more remote Brewster division.

Corollary to our findings, Staff recommends that NYSEG and Con Edison increase their internal overhead line FTE resources to previous levels. For NYSEG, this would be increasing internal overhead line resources by 100 to 150 FTEs. These resources should be appropriately distributed across NYSEG’s New York State service territory; however, initial resource increases should be made to the non-contiguous areas within its service territory. Con Edison should increase its internal overhead line resources by 30 to 50 FTEs. The addition of these resources should be viewed as incremental to current internal staffing numbers in the short term as each of the utilities should be performing additional storm hardening activities to mitigate the impact of future storms.

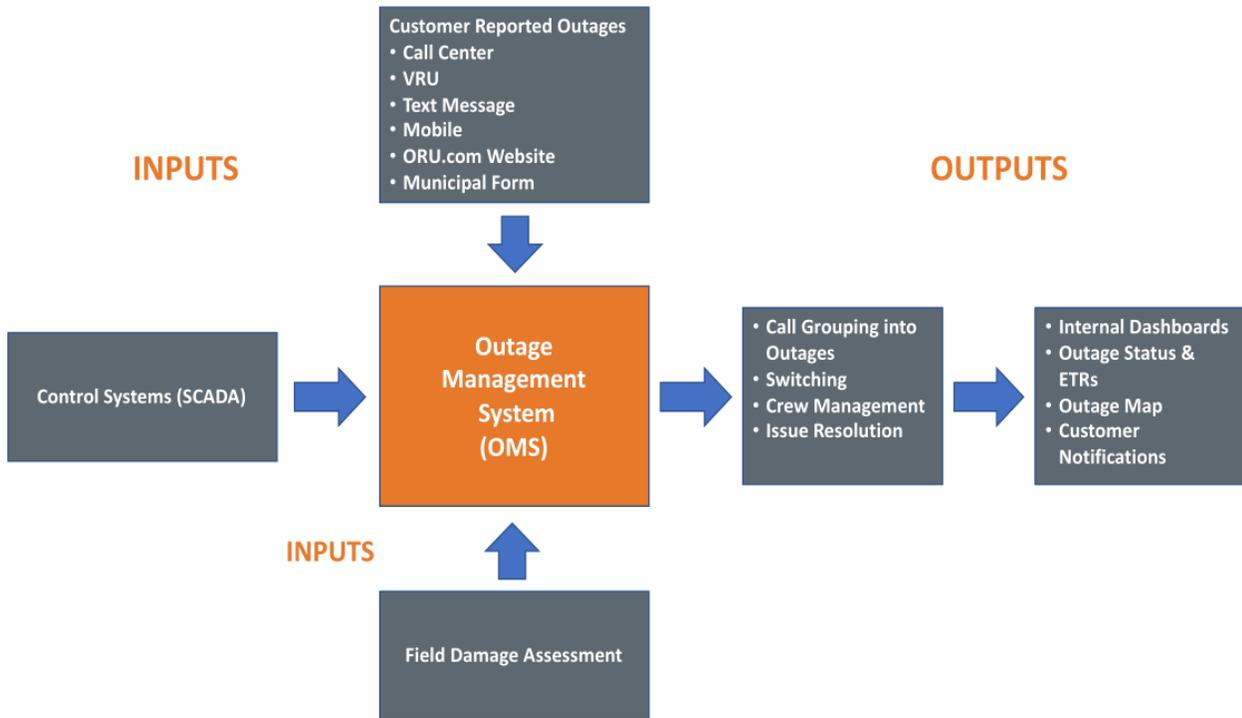
Figure 10: OMS Process Flow Diagram<sup>66</sup>

Figure 10 shows a process flow diagram from Orange & Rockland that depicts the typical flow of information through OMS between applications. Since OMS is connected to many independent functions and acts as a definitive source of information for many applications, it is imperative that the system processes accurate information and remains functional even when other applications are impacted.
